Martin Gwilliams
Progress update August 2020

Making and amends

In August Martin has been focusing mainly on the tasks he has been given to carry out around the 14th century window of the apsidal chapel of the north ambulatory.

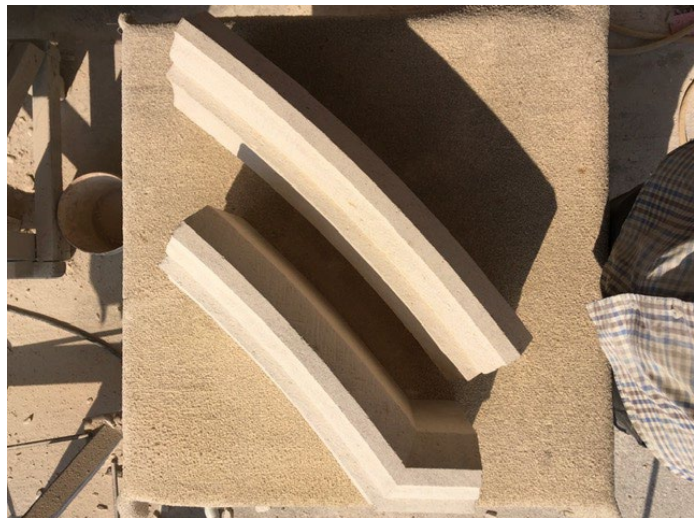
He writes: I made steady progress and completed the working of the stone components for the hoodmould. Working these stones gave me the opportunity to continue practicing and developing my banker masonry skills, being particularly careful and true in the reproduction of the moulding of the hood. Thanks to some top tips and a master class from Pascal while making the two components, I feel I am making steady progress. For the first stone I only used hand tools: chisels, claws,

punches, hammers, and mallet; for the second I was shown how to, and used a large and smaller grinder to take away large areas of stone, before using the hand tools again to finish the piece off. Using the grinders certainly helped to speed up the process of working the stone as I completed the second stone in the half the time I took to produce the first one.

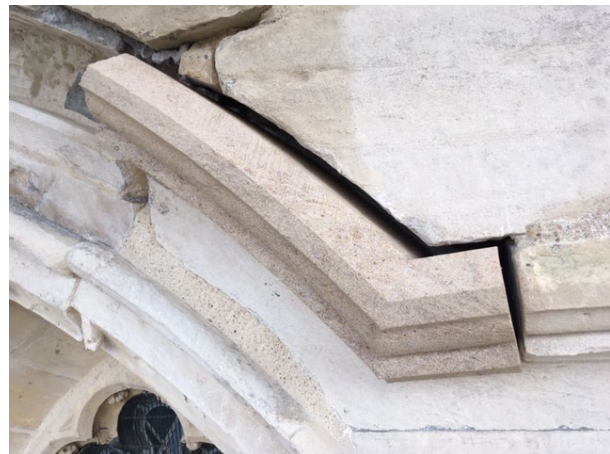
With the stones complete I was now in the position to start fixing the stone in place. Sadly, however, it was at the first attempt of 'dry fixing' - inserting the stone to the space in which it goes – that I encountered a modest but costly error. A mistake I had made without realising it when recording the measurements and angles of the old stones, which I then subsequently transferred when setting out the hoodmould now meant that the trajectory of the return - the portion of the moulding running horizontally - made it impossible to fix in the space as it was, because the curve was now running at too steep an angle to fit in its rightful place and maintain its rightful radius. So, plan B. I had to cut the stone in two. I made the cut quite close to the mitre and return so that the joint that now exists looks less obviously a mistake. It also helps the stones fit more correctly into the section that I had cut out for it.

setting out and drawing up the stones at full size; then making the two stones components. However, as my colleagues said, and the old saying goes, *we learn more from our mistakes*. I certainly hope so! After a disturbed night's sleep, going over the error in my mind, the next day I began the task of making the best of the situation that I had created.

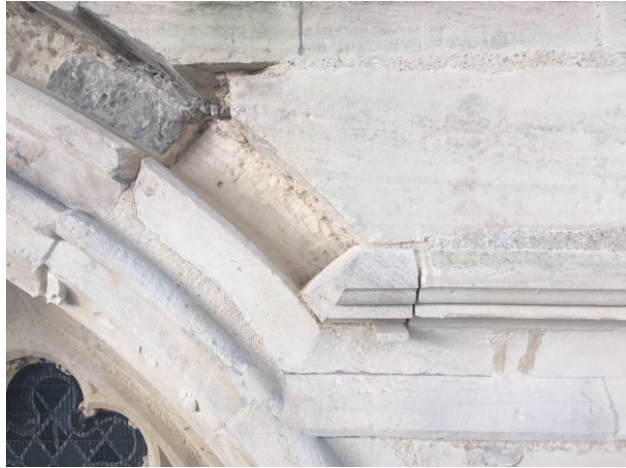
It is important when laying stones on a bed of mortar to make sure that the stone is wet, though just enough to stop the stone from sucking all the moisture out of the bed of mortar on which it will sit. However, fixing needs to be swift, otherwise the bed of mortar can end up being 'dead' - lifeless and purposeless - the whole process would need to be done again with a fresh bed of mortar. So with my stone wetted, I presented to the space and gently and swiftly slid it into position. I then used my straight edge and to check that the fillet – the nose of the stone – and the other elements of the moulding were in line with the same elements in the stone adjacent to it, when doing restoration work this a matter of careful judgement as the profiles of the stones will be slightly different in places due to the weathering a erosion of the older stone. I also used a spirit level to check the horizontal run of the top and bottom beds of the old and new stone. Two more stones to go...

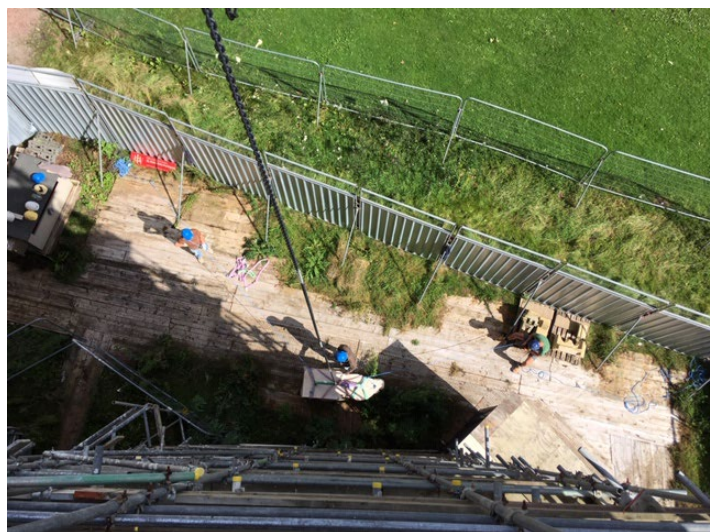
One morning in the penultimate week of August, I helped raise up the next one of the new gargoyles – the Cotswold Sheep Shearer – to be installed along the parapet of the north ambulatory. Raising the gargoyles from the ground to the top of the scaffold involved a good work out for my arms muscles. In a relay with one of the other members of the team, I pulled the very long chain, which ever so slowly winched the stone into the air and eventually up to the top. It
