Martin Gwilliams
Progress update June 2020

A happy return

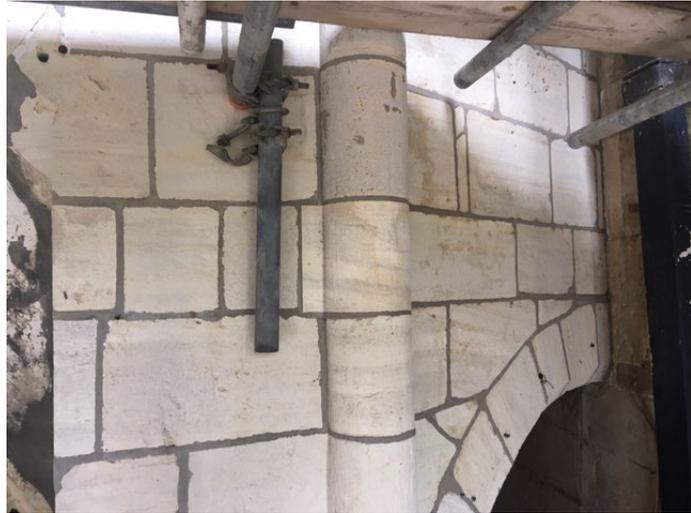
The first week back I was eased back into life at the Cathedral by joining my colleagues in the marathon task of cutting out the large, remaining portions of cement mortar which line the exterior of the east face of the north transept and the small section of the north ambulatory. Cement mortar was a kind of

‘wonder drug’ for the Victorian restorers of Cathedrals. It was used for repointing and at one time it would probably have been found somewhere in the joints of most of England’s Cathedrals. Cement mortar is impermeable so when it rains or there’s frost, moisture is drawn into the stones but then it can’t escape through the joints. Over time this will usually cause damage to the stone, rather than damage to the mortar and joints. Cement mortar is also incredibly hard. To remove it requires hardy chisels and a decent hammer although if the joints are wide enough a grinder might be used to make an initial cut which makes the removal of the cement using chisel and hammer a little easier. The common height of joints between the stone components became increasingly smaller as the centuries evolved. Early medieval joints can be around 10mm whilst late medieval and Victorian joints can be 4mm or even smaller, making the removal of the cement a delicate operation.

Cutting out the mortar is dirty work even though we are all fully kitted out in PPE for our health and protection. A good first week cutting out a large portion of the cement meant that by week two I was able to get back into the workshop to pick-up the projects I was working on back in March.

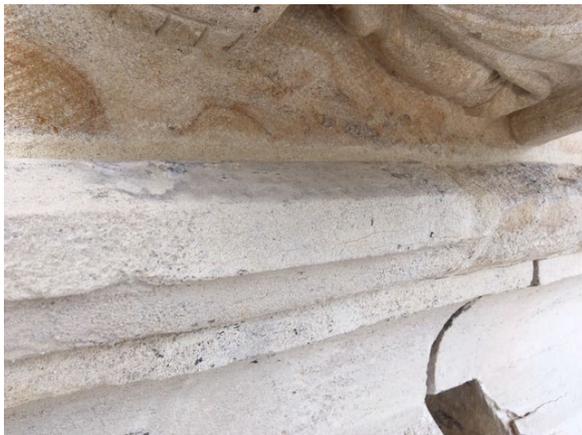
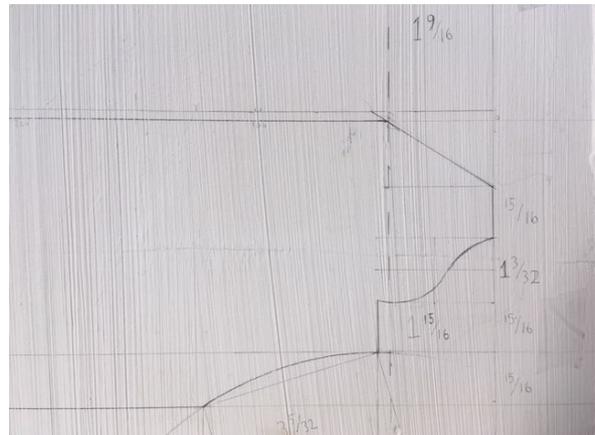
I returned to the notes and drawings made nine weeks previously and reminded myself of the project and tasks. Setting Out projects require a stonemason to become a little bit like Hercule Poirot, although without the murder. Being archaeological detectives requires stonemasons to develop Hercule-like 'little grey cells' in order to devise the most appropriate repair. Before lockdown I had begun the work to restore a hood mould over a 14th century window. I studied two sections of moulding in order to take the measurements to set out my drawing. Pascal encouraged me to look at a third section where the new Forest of Dean Miner gargoyle has recently been installed. There is a section of the moulding which is in really good condition suffering very little erosion. Taking a full set of fresh measurements of this moulding I found that certain parts of these stones were 3 - 5mm larger than the other sections I had measured back in March. That might not seem significant but even 1 or 2mm difference causes problems for masons when it comes to fixing the stone. Although there are tricks of the trade to work around when stones don't line up either side it's far better to avoid that with careful measuring.

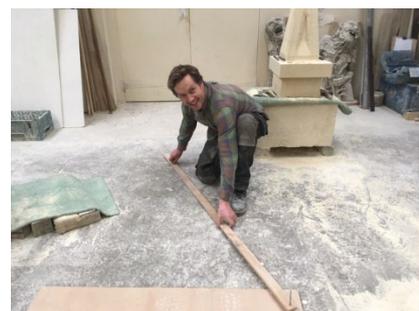
With my new set of measurements, I returned to the workshop and made a full-size drawing of the profile of the hood and mould. I used a beam compass (a compass able to produce large radii) to set out the radius of the arch which is required to complete the set of drawings. I will then create templates in order to start working the stone. This will happen over the next few weeks. Once this is complete, I can then start on my next practical module which is fixing these stones in place.

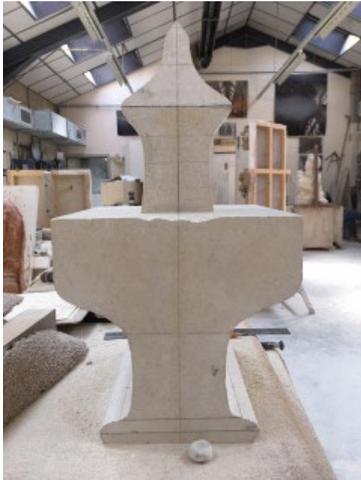
The last week of June gave Martin opportunity to get back to working stone. Martin writes: I had the pleasure of working a finial. These are top portions of the pinnacles which sit proudly on the parapet of the north ambulatory. It is the most intricate piece of stone I have carved to date and I can see how the tasks Pascal has set me so far have led to me being able to work pieces like this. If I had been given this to produce in week one back in September I would have been completely out of my depth. I now can draw upon all that I have learnt to date and I channelled this into creating the best finial I can. I am really enjoying learning more skills and gaining more knowledge and understanding in the process. I also know that there will always be room for improvement.

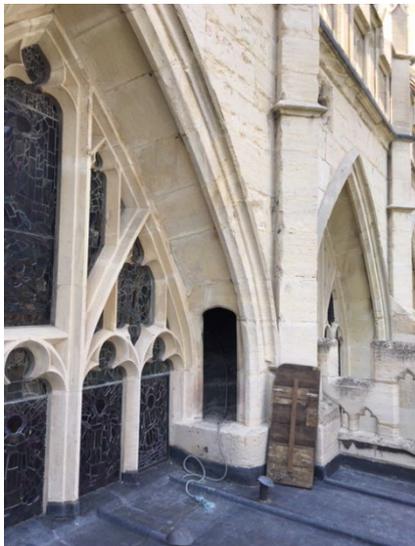
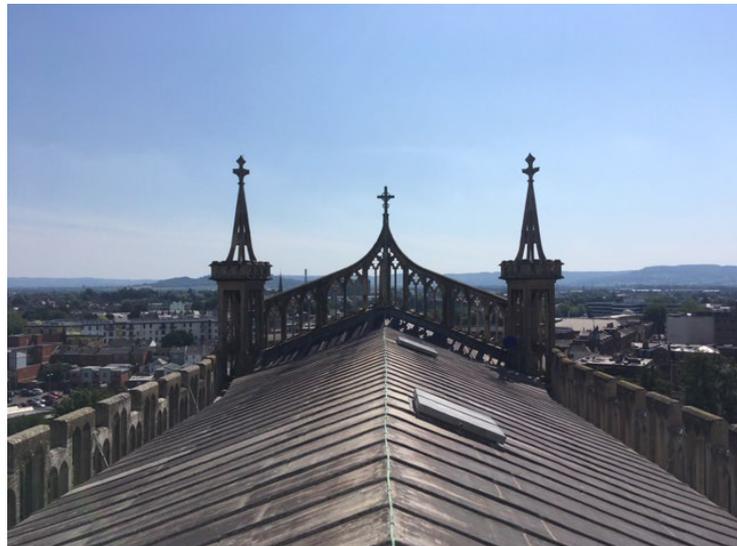
June ended on a high for Martin. He writes: Where better to spend a sunny June day than clearing out the gutters all along all the roof tops of Gloucester Cathedral? Maintenance of the gutters is essential so that they and the gargoyles can work effectively. Heavy rain in June along with high winds brought down moss from the roofs and sills to collect in the gutters alongside the animal bones and carcasses left by birds. Although messy and, at times, unpleasant this also brought the pleasure of seeing the high spaces and places of the Cathedral close-up, not to mention the views of the surrounding area. Accessing some of the gutters requires squeezing through some tiny gaps and doors using all the flexibility my old snake-like hips will allow!
