Martin Gwilliams
Progress update March 2021

Firm Foundation

Pinnacle of my Career!

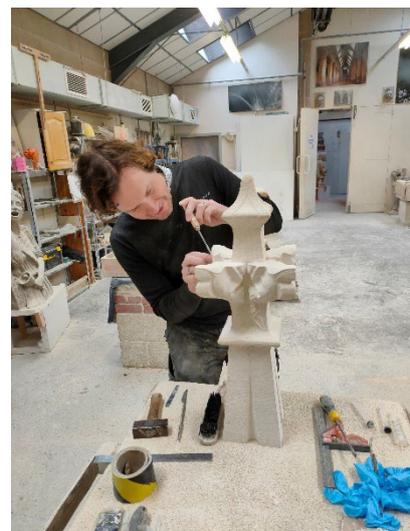
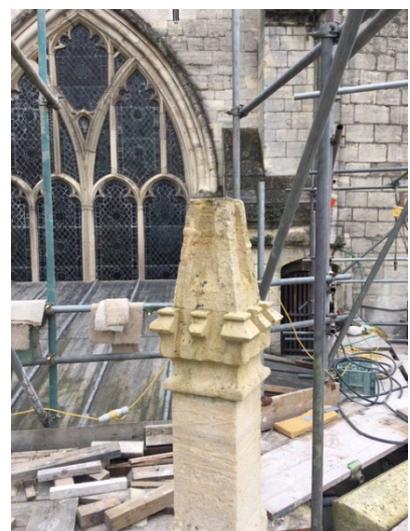
The two main types of stone (there are over 80 types that have been identified) used to build and restore the Cathedral were from quarries in Painswick and Minchinhampton. The medieval versions of Painswick and Minchinhampton stones have weathered incredibly well. In the case of the pinnacles of the north ambulatory that were restored in Victorian times, these were carried out using inferior versions of Painswick and Minchinhampton stones with soft beds that had led to their early demise. The types of stone used in the 1960s experiment were: Sherstone, Monks Park and a 19th century version of Painswick. The various portions of the pinnacles – the shaft (bottom), the pinnacle (middle) and the finial (top) were made using either one or a combination of two or three of the experimental types of stone for the various portions. Sadly, by the 1980s, some of these pinnacles were already showing signs of dilapidation. By the quinquennial inspection of 2014 they were all deemed in need of restoration. These experimental types of stones were (hindsight I great gift) unsuitable for this area and aspect of the Cathedral. However, since a more scientific approach to stone testing didn't start until the 1970s, I think we can be forgiving of those carrying out this type of test.

Before fixing the new stones in place, I had to carefully carry out structural repairs by inserting long stainless-steel dog cramps (they look like large staples) across the soft beds on the 1960s Monks Park sections of the pinnacle. I had to delicately cut a modest channel and drill a couple of holes for the cramp to slot into. Once in place, I was able to point up the channel and consolidate the soft beds with mortar.

As part of the north ambulatory project, most of the pinnacles along the parapet have been fully restored with new stone. The one I fixed this month only needed a new top section of the pinnacle and a new finial. Having pinned together the two elements which I had previously made, I drilled holes of around 3 inches in the top and bottom beds of the piecing of the pinnacle and in base bed of the finial. Then I glued a 6-inch piece of stainless-steel dowel into the holes. I then drilled a hole in the top of the old section of pinnacle for this to receive the dowel glued into the elements I had made. All happily and safely fixed in place and pointed up, I allowed myself a brief moment to rejoice at the sight of my work before it was onto the next thing - shelter-coating the Monks Park sections of the pinnacle.

The shelter-coat protects the stone from the elements, prolonging its life and it also helps it to blend in with the new, restored elements. The ingredients of the shelter-coat are lime putty and stone dust blended with water and is simply applied with a brush. All this work should at least last until a future generation of stonemasons come round to working on this section of the building again.

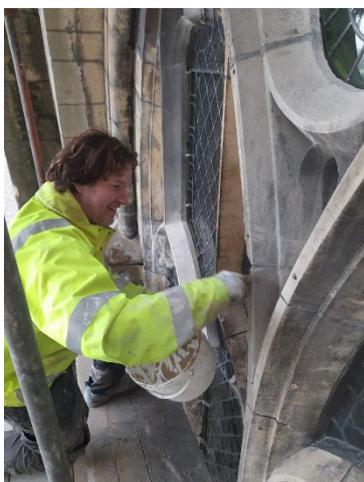
In March I have been cleaning and restoring the outside of one of the windows of the north transept. Portions of the stonework were covered in sulphur, which had been slowly eroding the surface of the stones. Regular readers will remember that back in January I was cleaning and restoring the stonework around the window at the base of the west face of the tower. The cleaning process is carried out using an ammonium-based poultice - a paste - which is applied to the stone and sulphur which is then covered with cling film to stop the poultice drying out too quickly. Once it is dry, the poultice peels off taking some (or all) of the sulphur with it. This process is repeated as many times as needed for the surface of the stone is clear of the sulphur. It is delicate operation as there are some historic mason's marks and scribe lines on the face of some of the medieval stones, which need to be preserved.

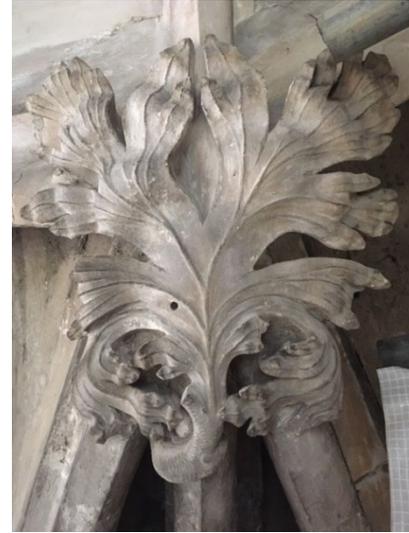
Part of my task was also to clean and dust the inside of same north transept window. This meant climbing the scaffold in transept to reach the window. The task afforded some excellent views of the Cathedral. It was a great opportunity to get up close with some of the lovely foliage carved on the bosses around this part of the ceiling. Bloomin' marvellous!
